PROPERTY INSPECTION REPORT

Prepared For: Mr. and Mrs. Jones
(Name of Client)

Concerning: 1234 Main Street Anytown, USA 10101
(Address or Other Identification of Inspected Property)

By: Bennie McDaniel License # 10386 05/02/2014
(Name and License Number of Inspector) (Date)

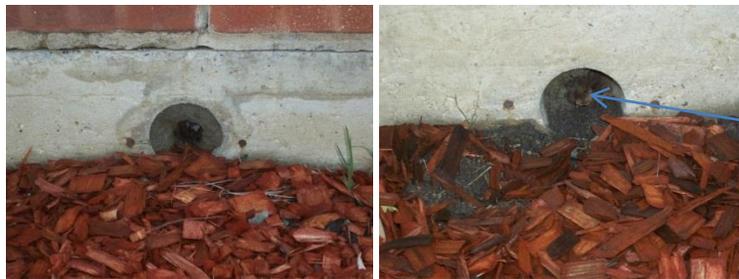
Comments: The foundation is performing as intended. Some problems were observed. The problems that were observed were there is no rendering around the entire perimeter of the house. Rendering is a process that most home builders use to provide a smooth finish around the outside of the foundation when they finish the foundation. It also covers all of the post tensions cables exposed ends. As a result of the foundation not having any finish around the foundation all of the post tension cables are exposed on the north and east side of the house. This is a safety hazard. This is a safety hazard because over time the tension in the cables can cause the cables to break at which time the cables can be forced out of the foundation at these exposed areas.

Post tension cable not covered

I recommend that a professional masonry company evaluate and correct the rendering around the foundation.

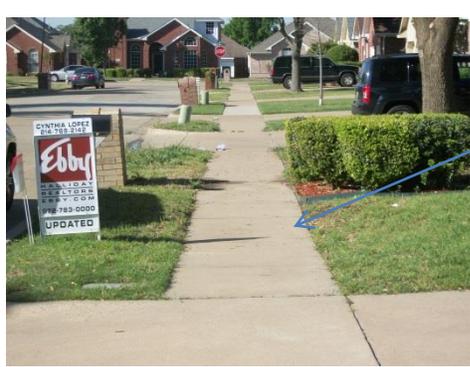
B. Grading & Drainage *Comments:* This property has a negative grade in the front yard. This is what you want so that the water flows away from the property. However, the sidewalk in the front has a noticeable dip in the middle of the front walk. This is a concern in that there is the exact same dip in the front walk on the property directly across the street. The dip could only be that the soil was not prepared correctly before the sidewalk was poured or there is an under lying issue with the ground under the sidewalk. I would recommend that a licensed landscape or licensed concrete professional evaluate and access why the sidewalk is not being supported by the soil underneath it.

There is a dip in the sidewalk here.

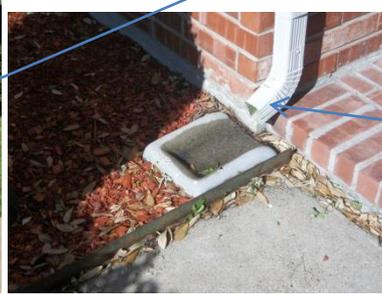
All of the gutter downspouts need to be extended to allow the water to be removed further away from the foundation. The downspouts are supposed to be extended out at least five feet from the foundation.

Downspouts should extend at least five feet

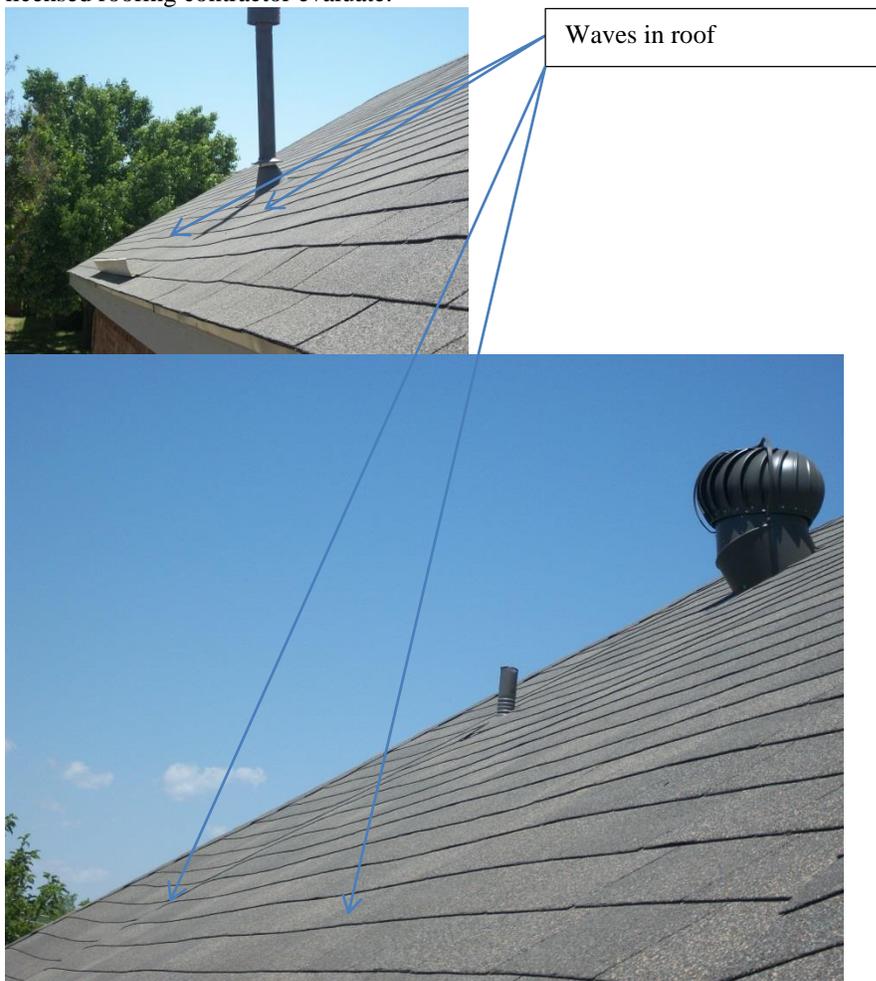
Comments: The roof is in fairly good condition. There are several areas on the roof that are wavy. When a roof has signs of waves there can be several things that can cause it. Either the decking is too thin to hold the weight of the roofing material or the span of the rafters below it is too far apart thus allowing the roof to wave or actually sag making it look like there is waves in the roof. I did see some difference in the spans of some of the rafters below where the roof showed signs of not lying flat. As far as the thickness of the decking, they all seemed to be the same thickness. I would recommend that a licensed roofing contractor evaluate.

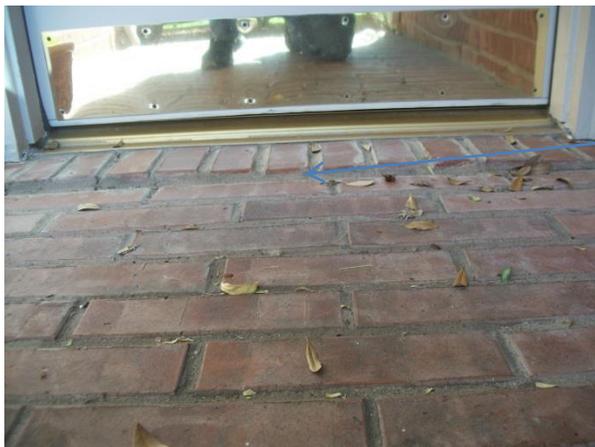
| <input checked="" type="checkbox"/> | <input type="checkbox"/> | <input type="checkbox"/> | <input checked="" type="checkbox"/> | K. Porches, Balconies, Decks, and Carports <i>Comments:</i> The front porch was working as intended. There is not a carport or balcony on this property. There is an issue at the front porch that needs attention. The bricks right in front of the front door were not installed level thus causing a possible tripping hazard. I recommend that a licensed professional brick layer correct the tripping hazard. |

These bricks in front of the front door pose a trip hazard.

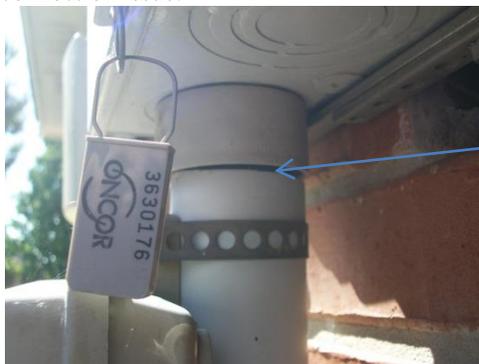
A. **Service Entrance and Panels** *Comments:* The electrical service entrance is located on the east side of the house. The service entrance and panels are working as intended. The conduit is not correctly connected to the service entrance. This is a safety hazard and this could cause moisture to penetrate into the main service panel. I recommend that a licensed professional electrician evaluate and correct the connection issue.

Conduit loose needs to be secured to service entrance

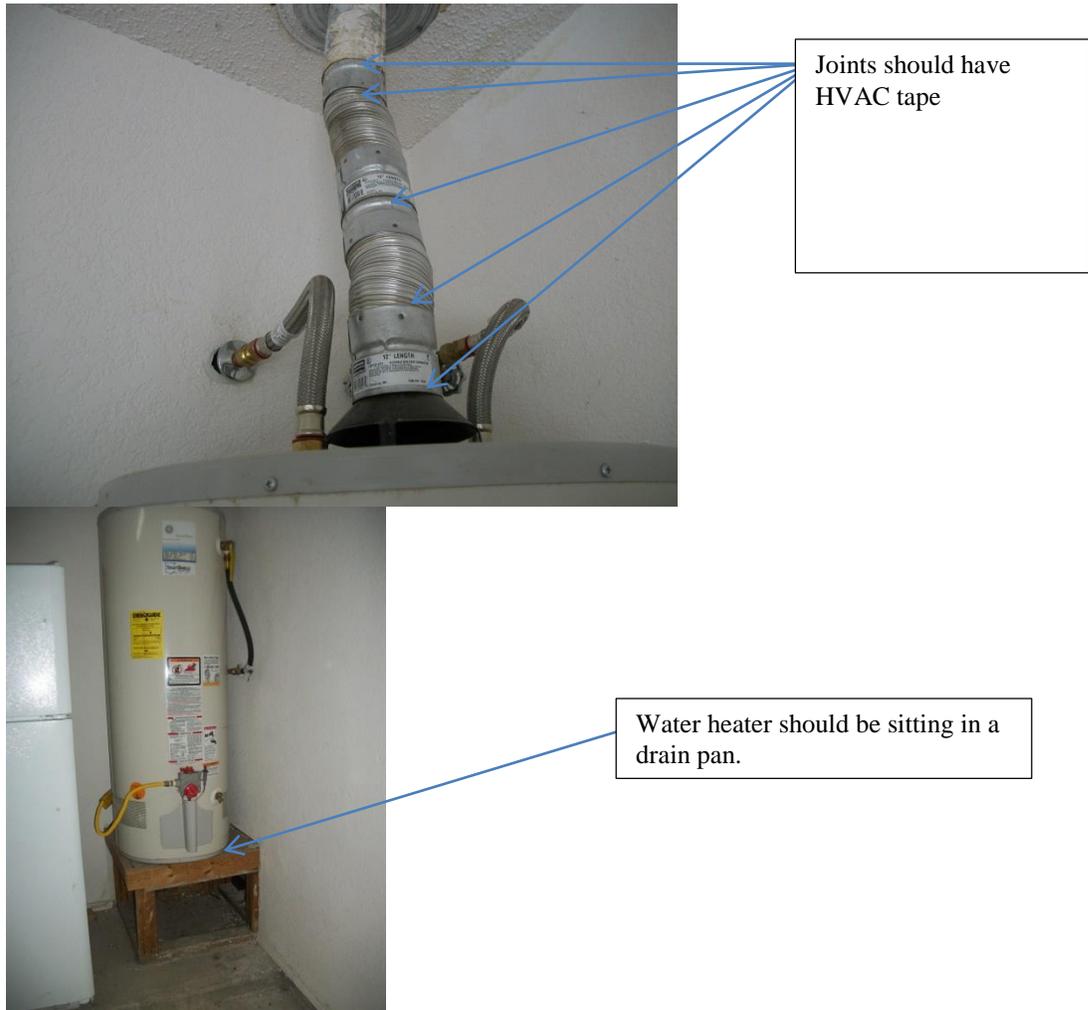
Comments: The hot water tank was working as intended. The hot water heater was installed in 2005. Most water heaters normally last between 5-8 years. The water heater does not have a drain pan under the unit which is required. The water pipes need to be insulated. The vent pipe should be secured at the connecting joints. I would recommend that a licensed plumber evaluate and correct the issues.

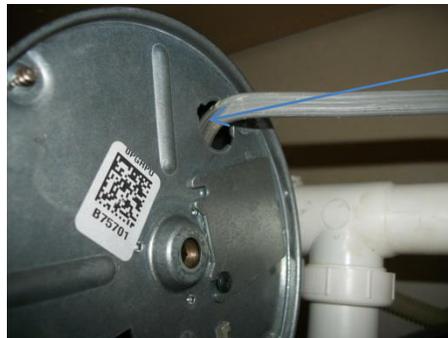
- A. Dishwasher** *Comments:* The dishwasher was not working at all. The drain line needs to be attached to the top of the cabinet to prevent backflow. Recommend having a licensed appliance technician evaluate.
- B. Food Waste Disposer** *Comments:* The food waste disposer was working as intended. However, the power cord needs to be routed through the correct grommet at the bottom of the unit to prevent the wire

casing from rubbing off and exposing the live wire to the bare metal of the disposer. I recommend that a licensed plumber or licensed electrician evaluate and correct.

Electrical cord must pass through correct grommet.

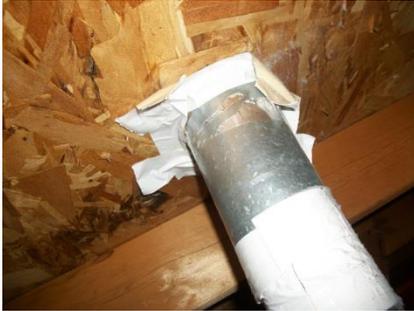
- H. Dryer Exhaust Systems** *Comments:* There was not a dryer present to verify that the vent work as intended. The vent does vent to the roof. The vent pipe section that goes through the roofs has tape wrapped around it that seems to be there to prevent water from getting into the attic area. I recommend that a licensed plumber or roofing specialist evaluate and make the necessary repairs to prevent any water from entering the attic area.
